## PHASE I ENVIRONMENTAL SITE ASSESSMENT

### WATER TREATMENT PLANT ST. PAUL ISLAND, ALASKA

**August 24, 2004**

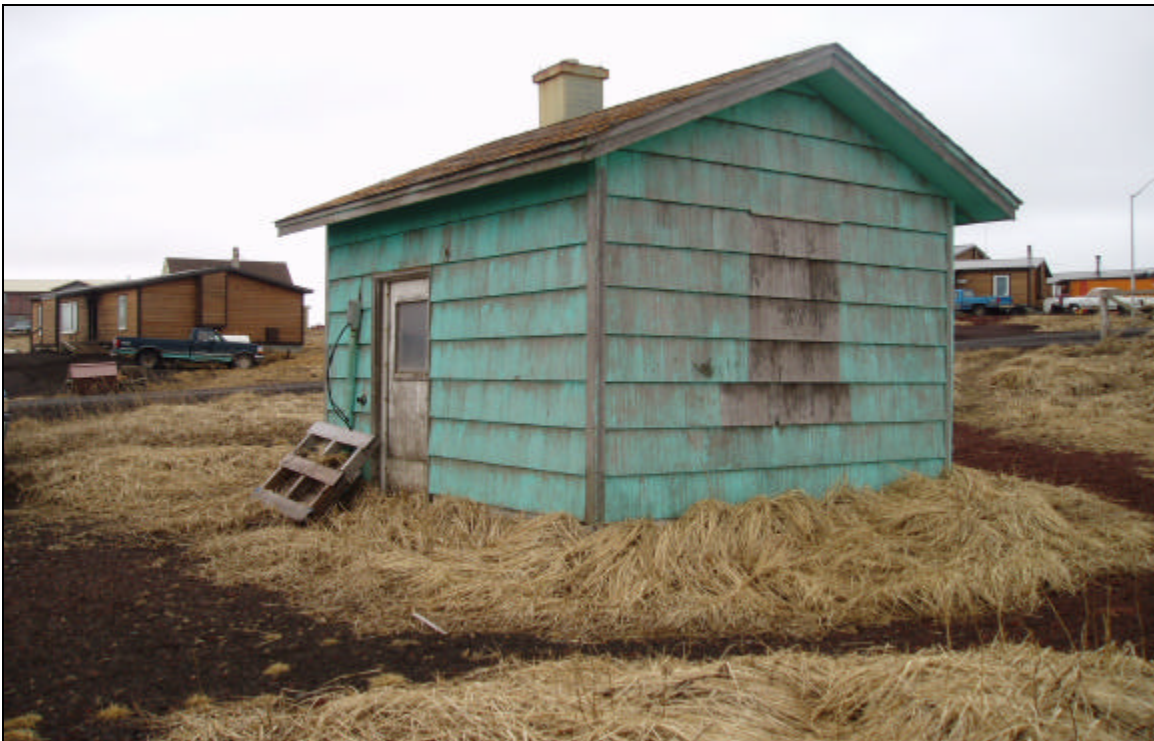
Photograph No. 1

Description: Looking north at the abandoned pump house adjacent to the property.

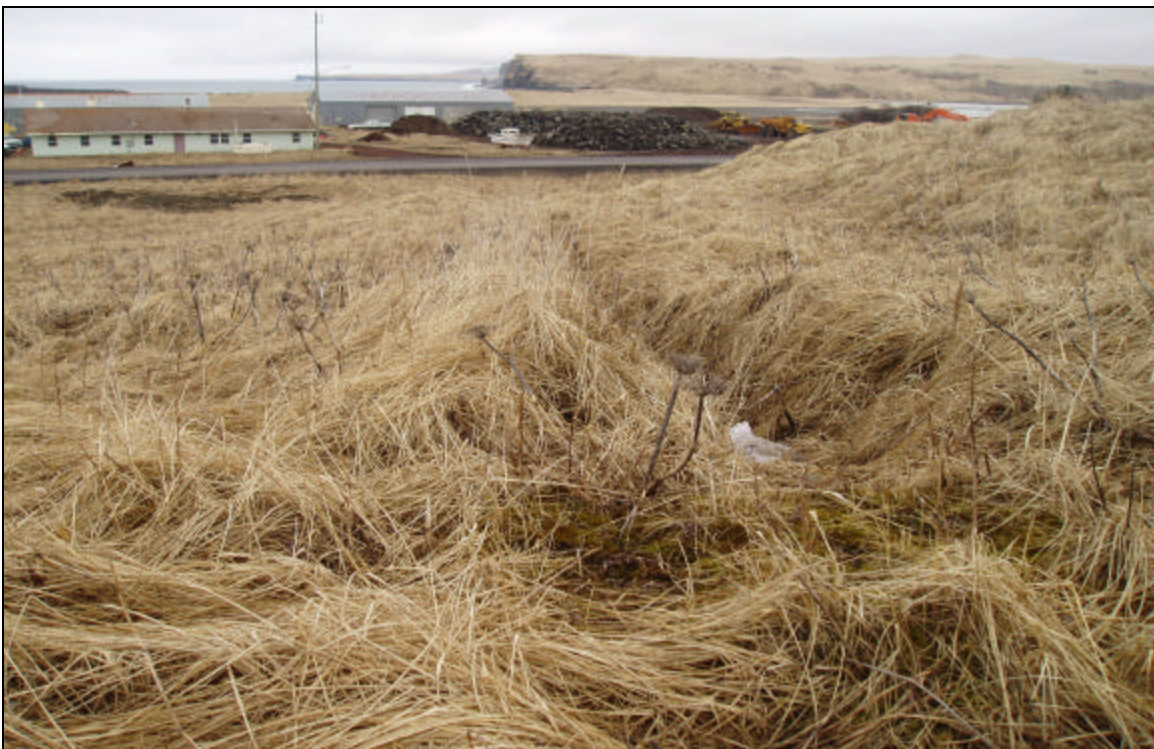
Photograph No. 2

Description: Looking west from the property.

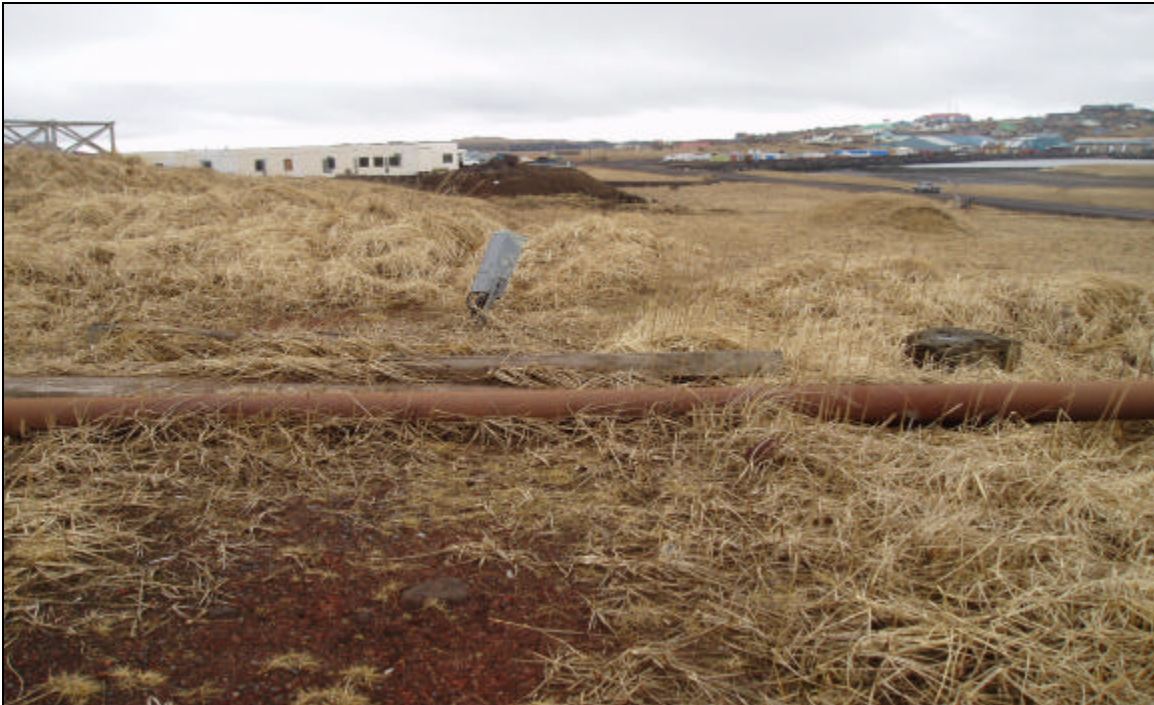
Photograph No. 3

Description: Looking south from the subject property. The newly constructed St. Paul Tribal Government building is visible in the background. A rusted pipe sits on the foreground of the adjacent property.

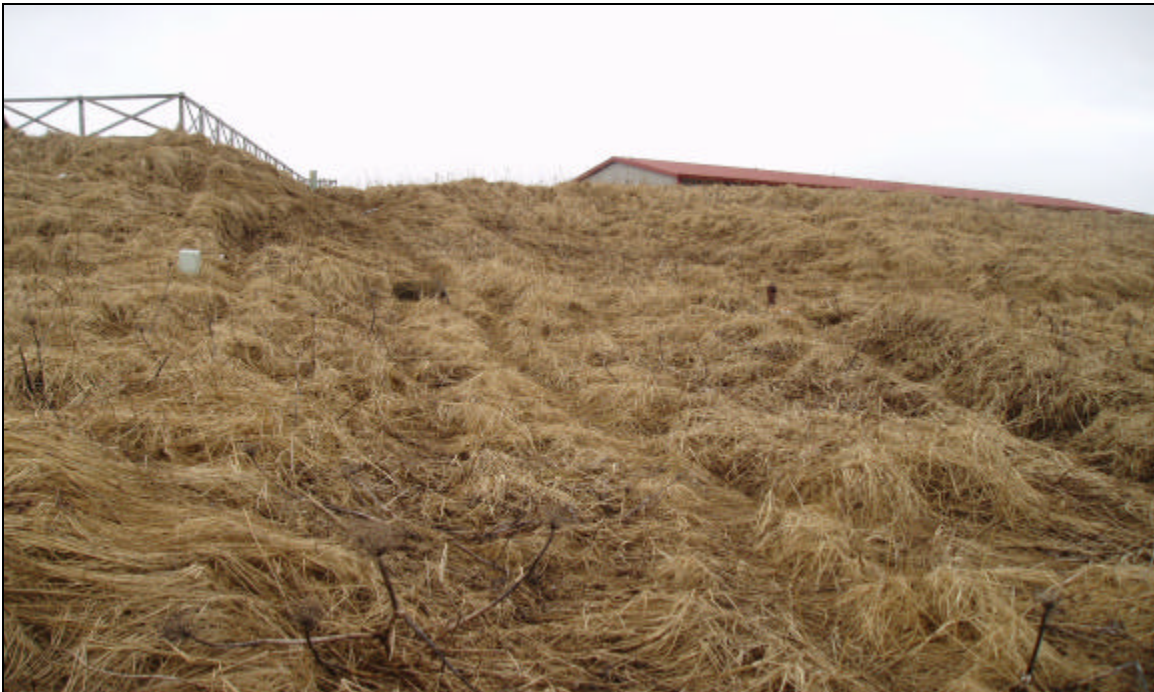
Photograph No. 4

**Observations:** No evidence of exterior discharges or waste disposal was observed during the site reconnaissance. A pipe remnant, presumably from one of the wells, was observed during the site reconnaissance. The metal pipe remnant protruded approximately 2 feet from the ground. The depth of the pipe was not determined.

Description: Looking east at the subject property. The presumed former fresh water well is located right of center, and an Alaska Communications System telephone pedestal is located left of center. The Senior Center is visible in the right background. A fence associated with residential property is also visible in the left background.

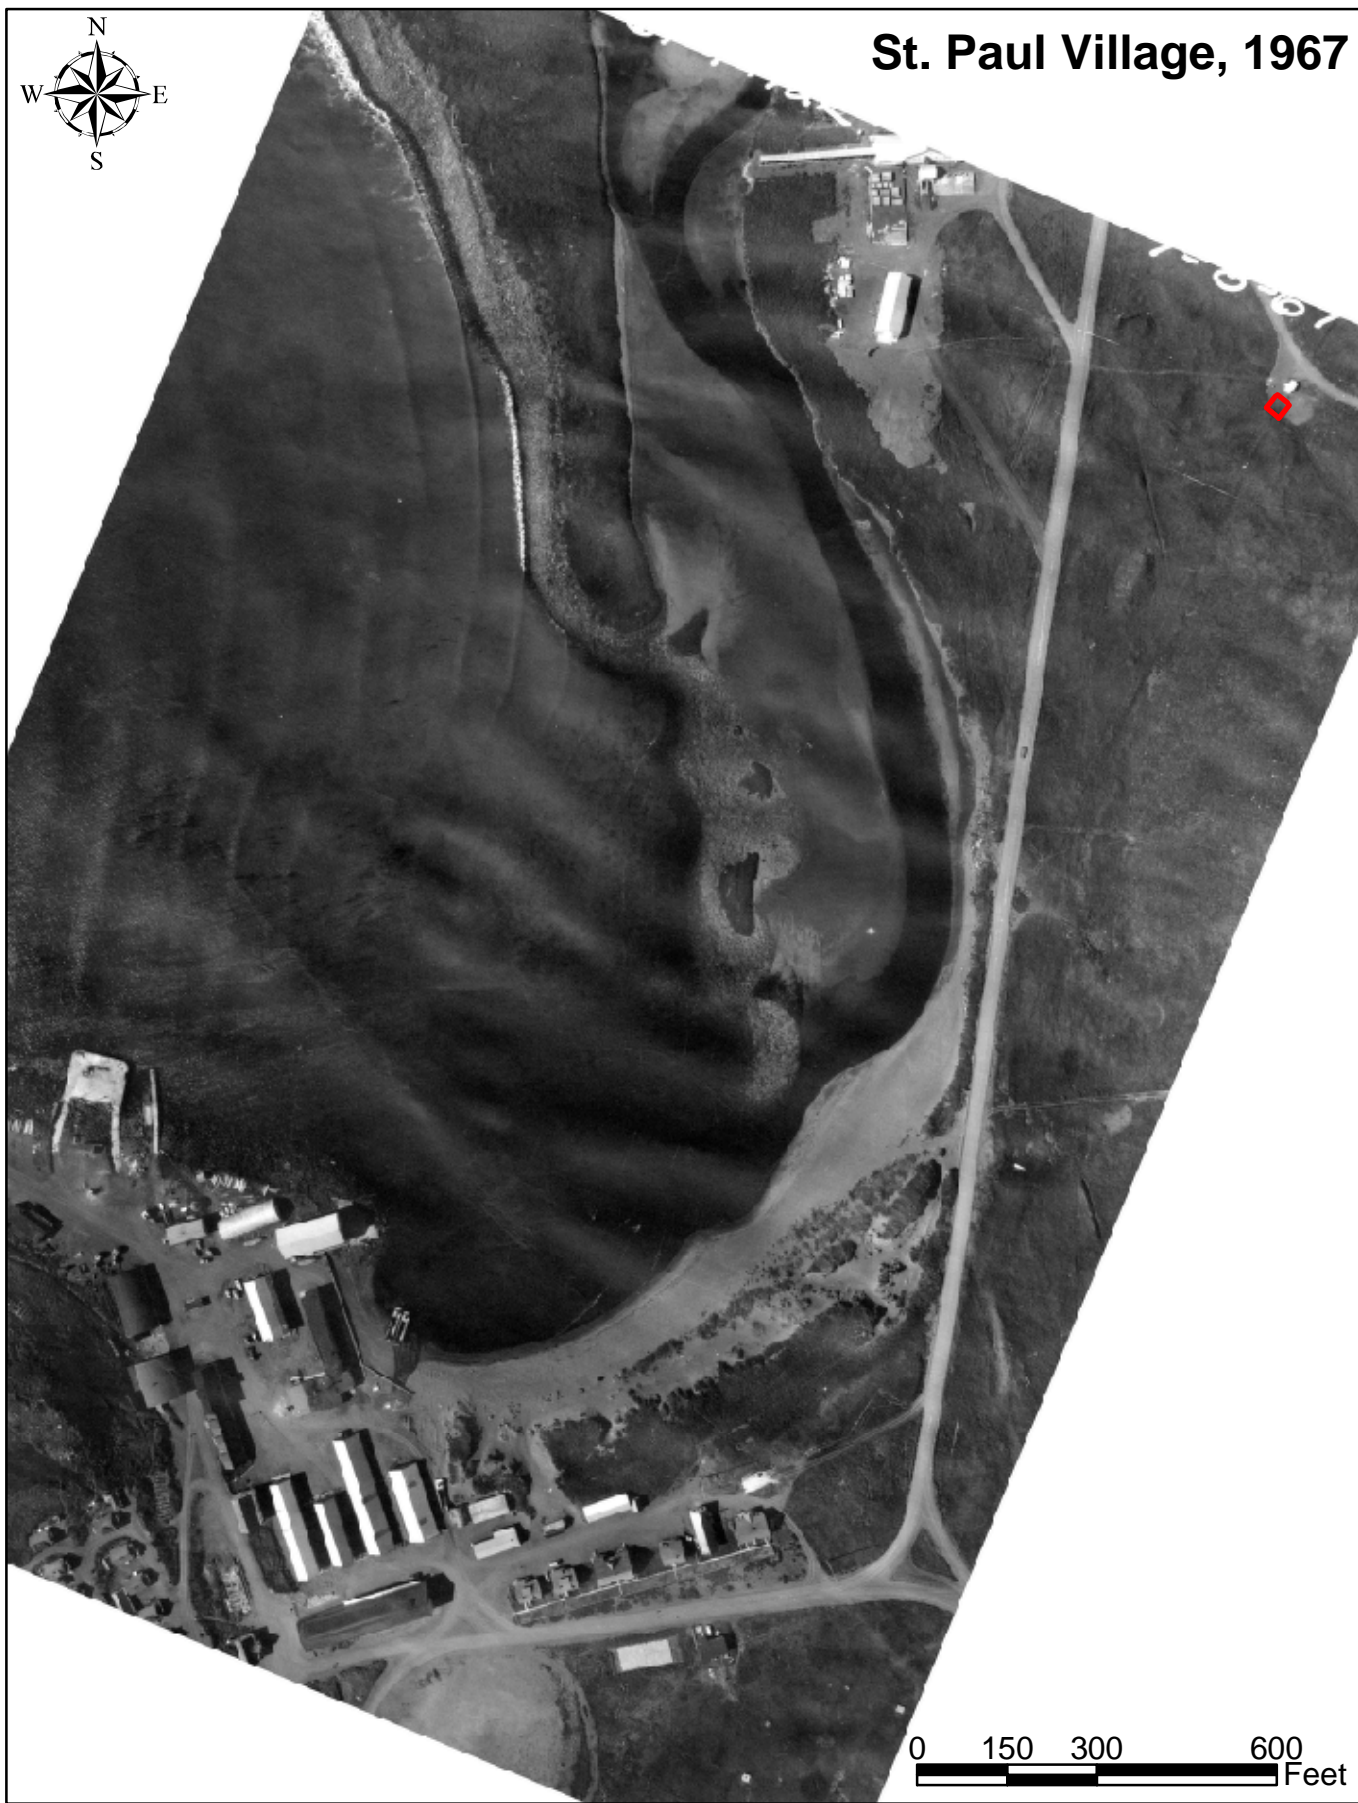
# St. Paul Village, 1967

- 
- **1967.** No buildings or structures are visible at the subject property. The pump house is visible north of the subject property. No other structures are visible surrounding the subject property.

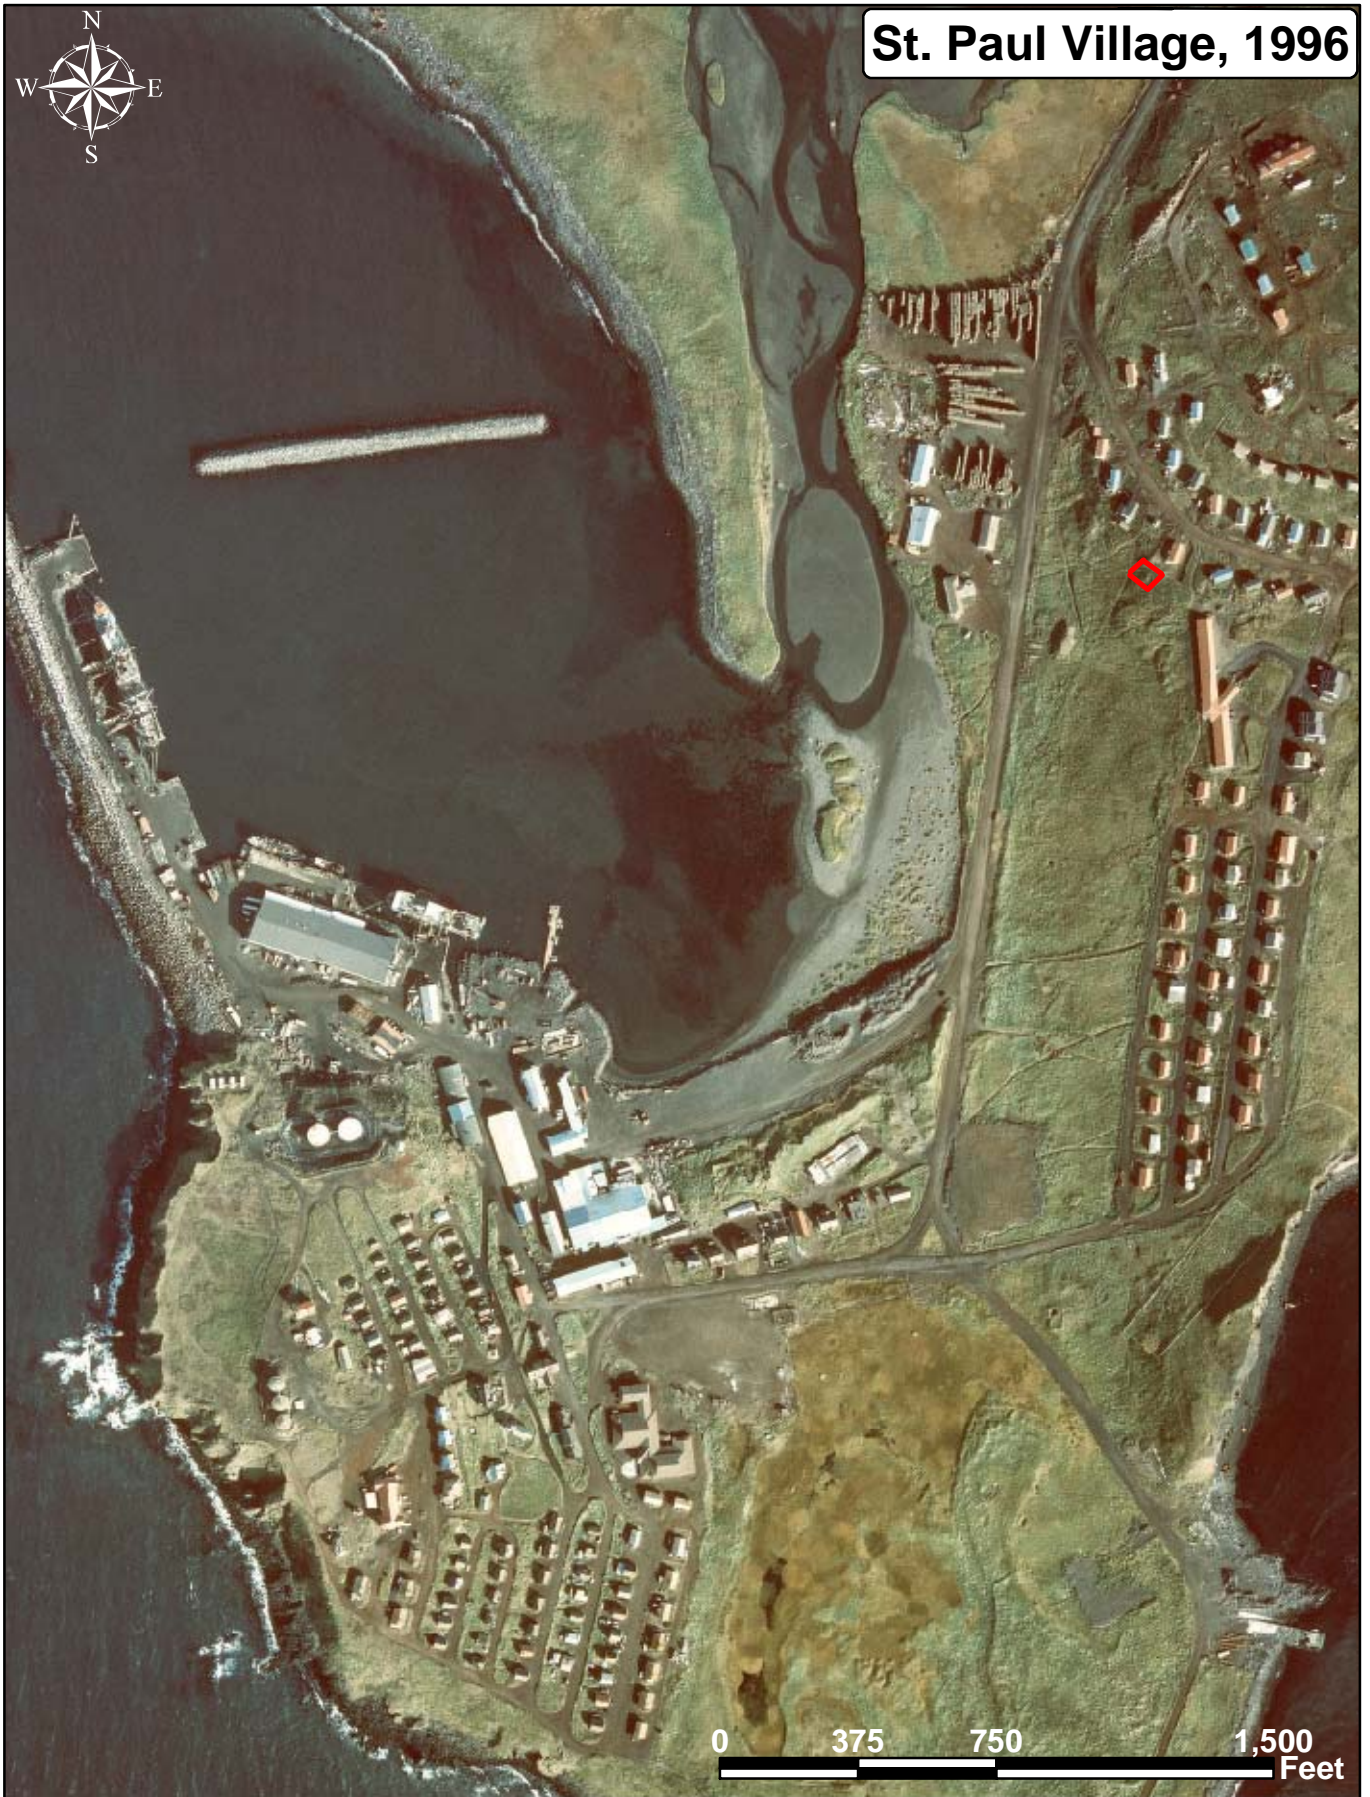
**St. Paul Village, 1996**

- **1996.** No buildings or structures are visible at the subject property. The abandoned pump house is visible north of the subject property. Other properties within the vicinity of the subject property are generally shown as exhibiting current conditions.
- **1973.** No buildings or structures are visible at the subject property. The pump house is visible north of the subject property. No other structures are visible surrounding the subject property.
